Observations at Didmarton Church, 1981

by R. Bryant
1983, Vol. 101, 183-185

OBSERVATIONS AT DIDMARTON CHURCH, 1981

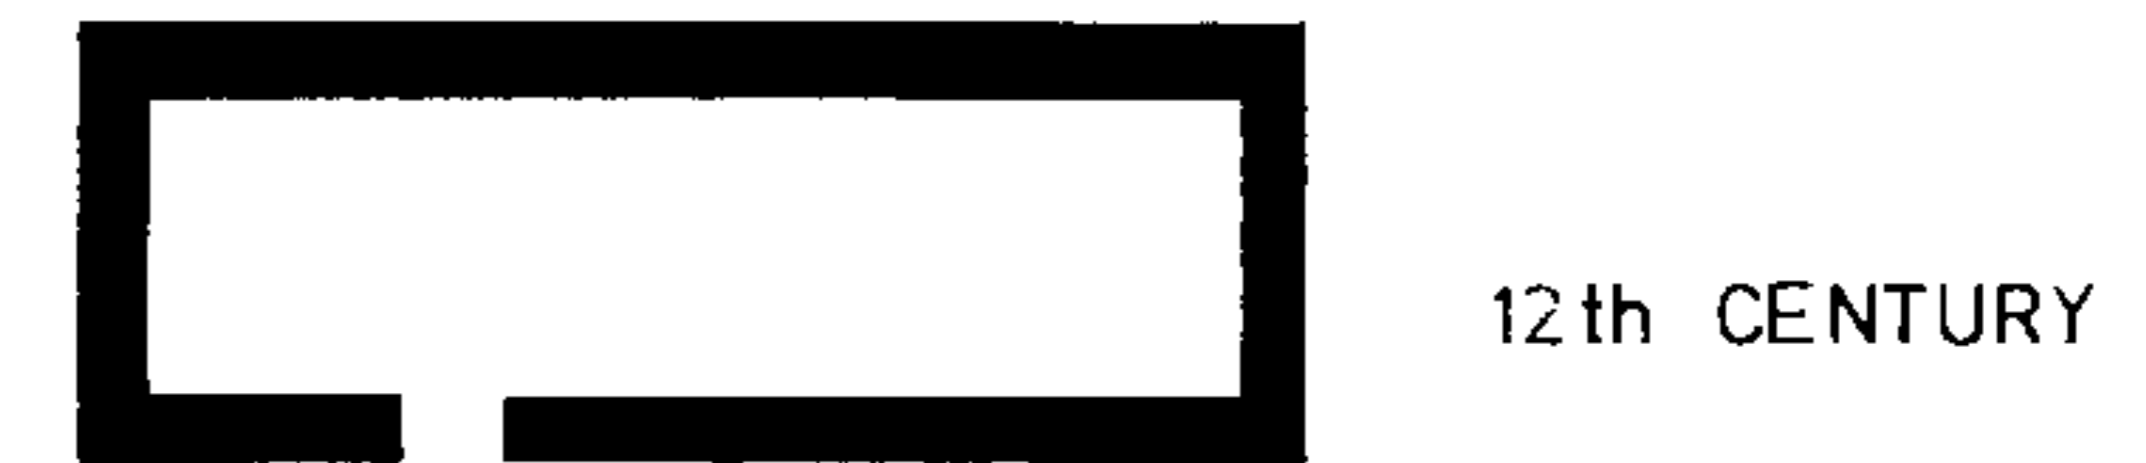
Early Development (a provisional sequence)

base has a double half-round moulding on the arris below a stopped-chamfer. Such mouldings are usually considered to be of the late 12th or early 13th century. The width of the narrower chancel is the same as the narrower nave. If they are contemporary, this may indicate a unitary plan, a scheme that appears to have been retained in the widened church.

Earlier observations, by Dr Warwick Rodwell, during trenching around the outside of the church showed that the north transept was straight-jointed onto the wall of the widened nave; the transept has a contemporary window with geometric tracery (mid 13th/early 14th century) in its north wall, thus dating the widening of the church to the mid 13th century or earlier, and, since the chancel quoin incorporates the 12th/13th-century architectural fragment, the most likely date is early in the 13th century. This means that the narrower church must belong to the 12th century or earlier.

Because of the wall scar, the west wall (F1) must be contemporary with the robbed north wall (F4) of the 12th-century church. The foundations for F1 cut a dark, sticky loam (8) and a layer of orange-brown sandy mortar (6). These layers therefore belong to an earlier building phase, of the early 12th century or before.

The south doorway of the nave, with its semi-circular head and heavy-roll moulding, seems to be of Norman date, adapted or rebuilt during the Georgian remodelling of the church. Observations inside the nave have shown that the threshold has been raised by approximately 0.35 m to the present floor level of the nave and south porch. Since the floor level of the porch is correct in relation to the bases of the porch arch, the lower threshold seems to be related to a lower, pre-porch ground surface.
