Medieval Smoke Vents and Low Room Walls in the Severn Plain

by L. F. J. Walrond with C. Powell
1985, Vol. 103, 163-173

The Old Bakehouse, Colethrop, Haresfield (FIGS. 1–3)

Doris' Cottage, Epney, Moreton Valence (FIGS. 6-7)

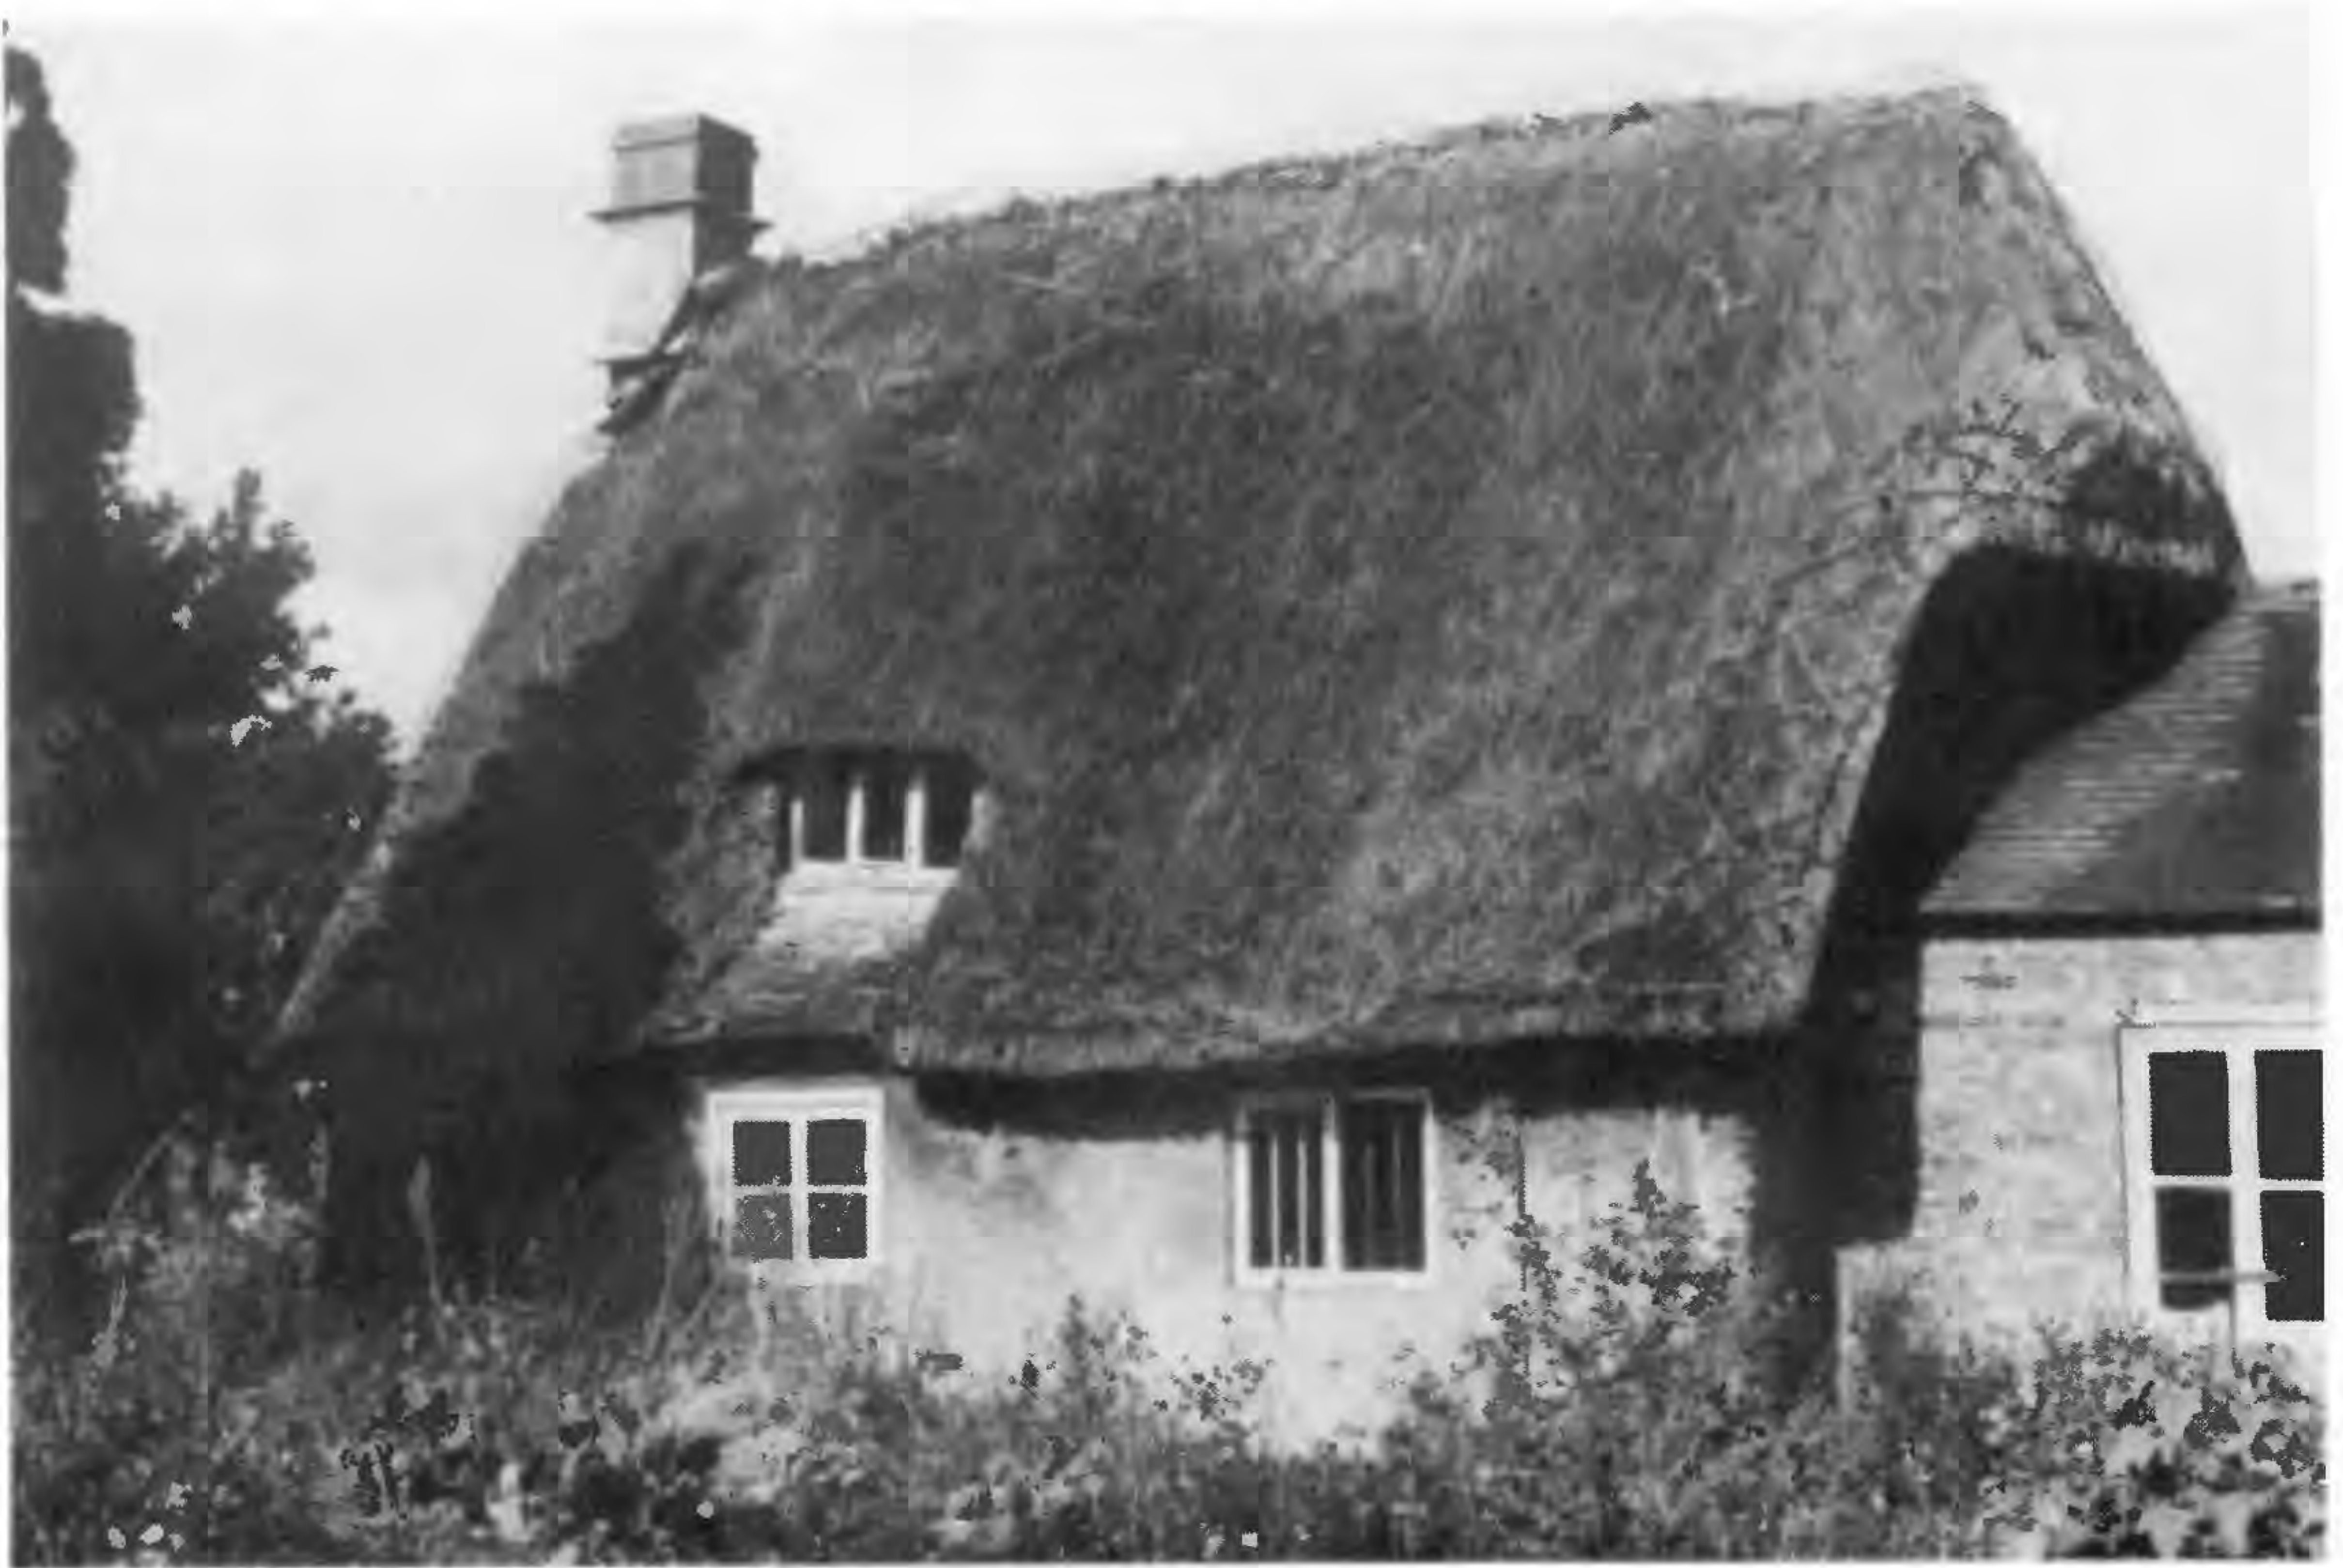
FIG. 1 The Old Bakehouse, Colethrop, Haresfield: south-east elevation in 1984.

appears to have contained a door head, giving access into the inner room at the point where a stair was later inserted. The principal entry is assumed to have been on the opposite side leading into the hall close to the south-west gable. The doorway through panel 5 was a Victorian modification and replaced a window. Pegs here and in panel 1 suggest that the windows were of oriel type projecting only a few inches (FIG. 4). The mullions would have been fixed into the sills, which were pegged to the main frame (cf. Denfurlong Farm, Frampton on Severn; demolished). The upper timber would have been pegged or nailed. A plank may have been fixed over the top of the sill beam partly for protection from rain and partly to inhibit plant growth from rotting the timbers.

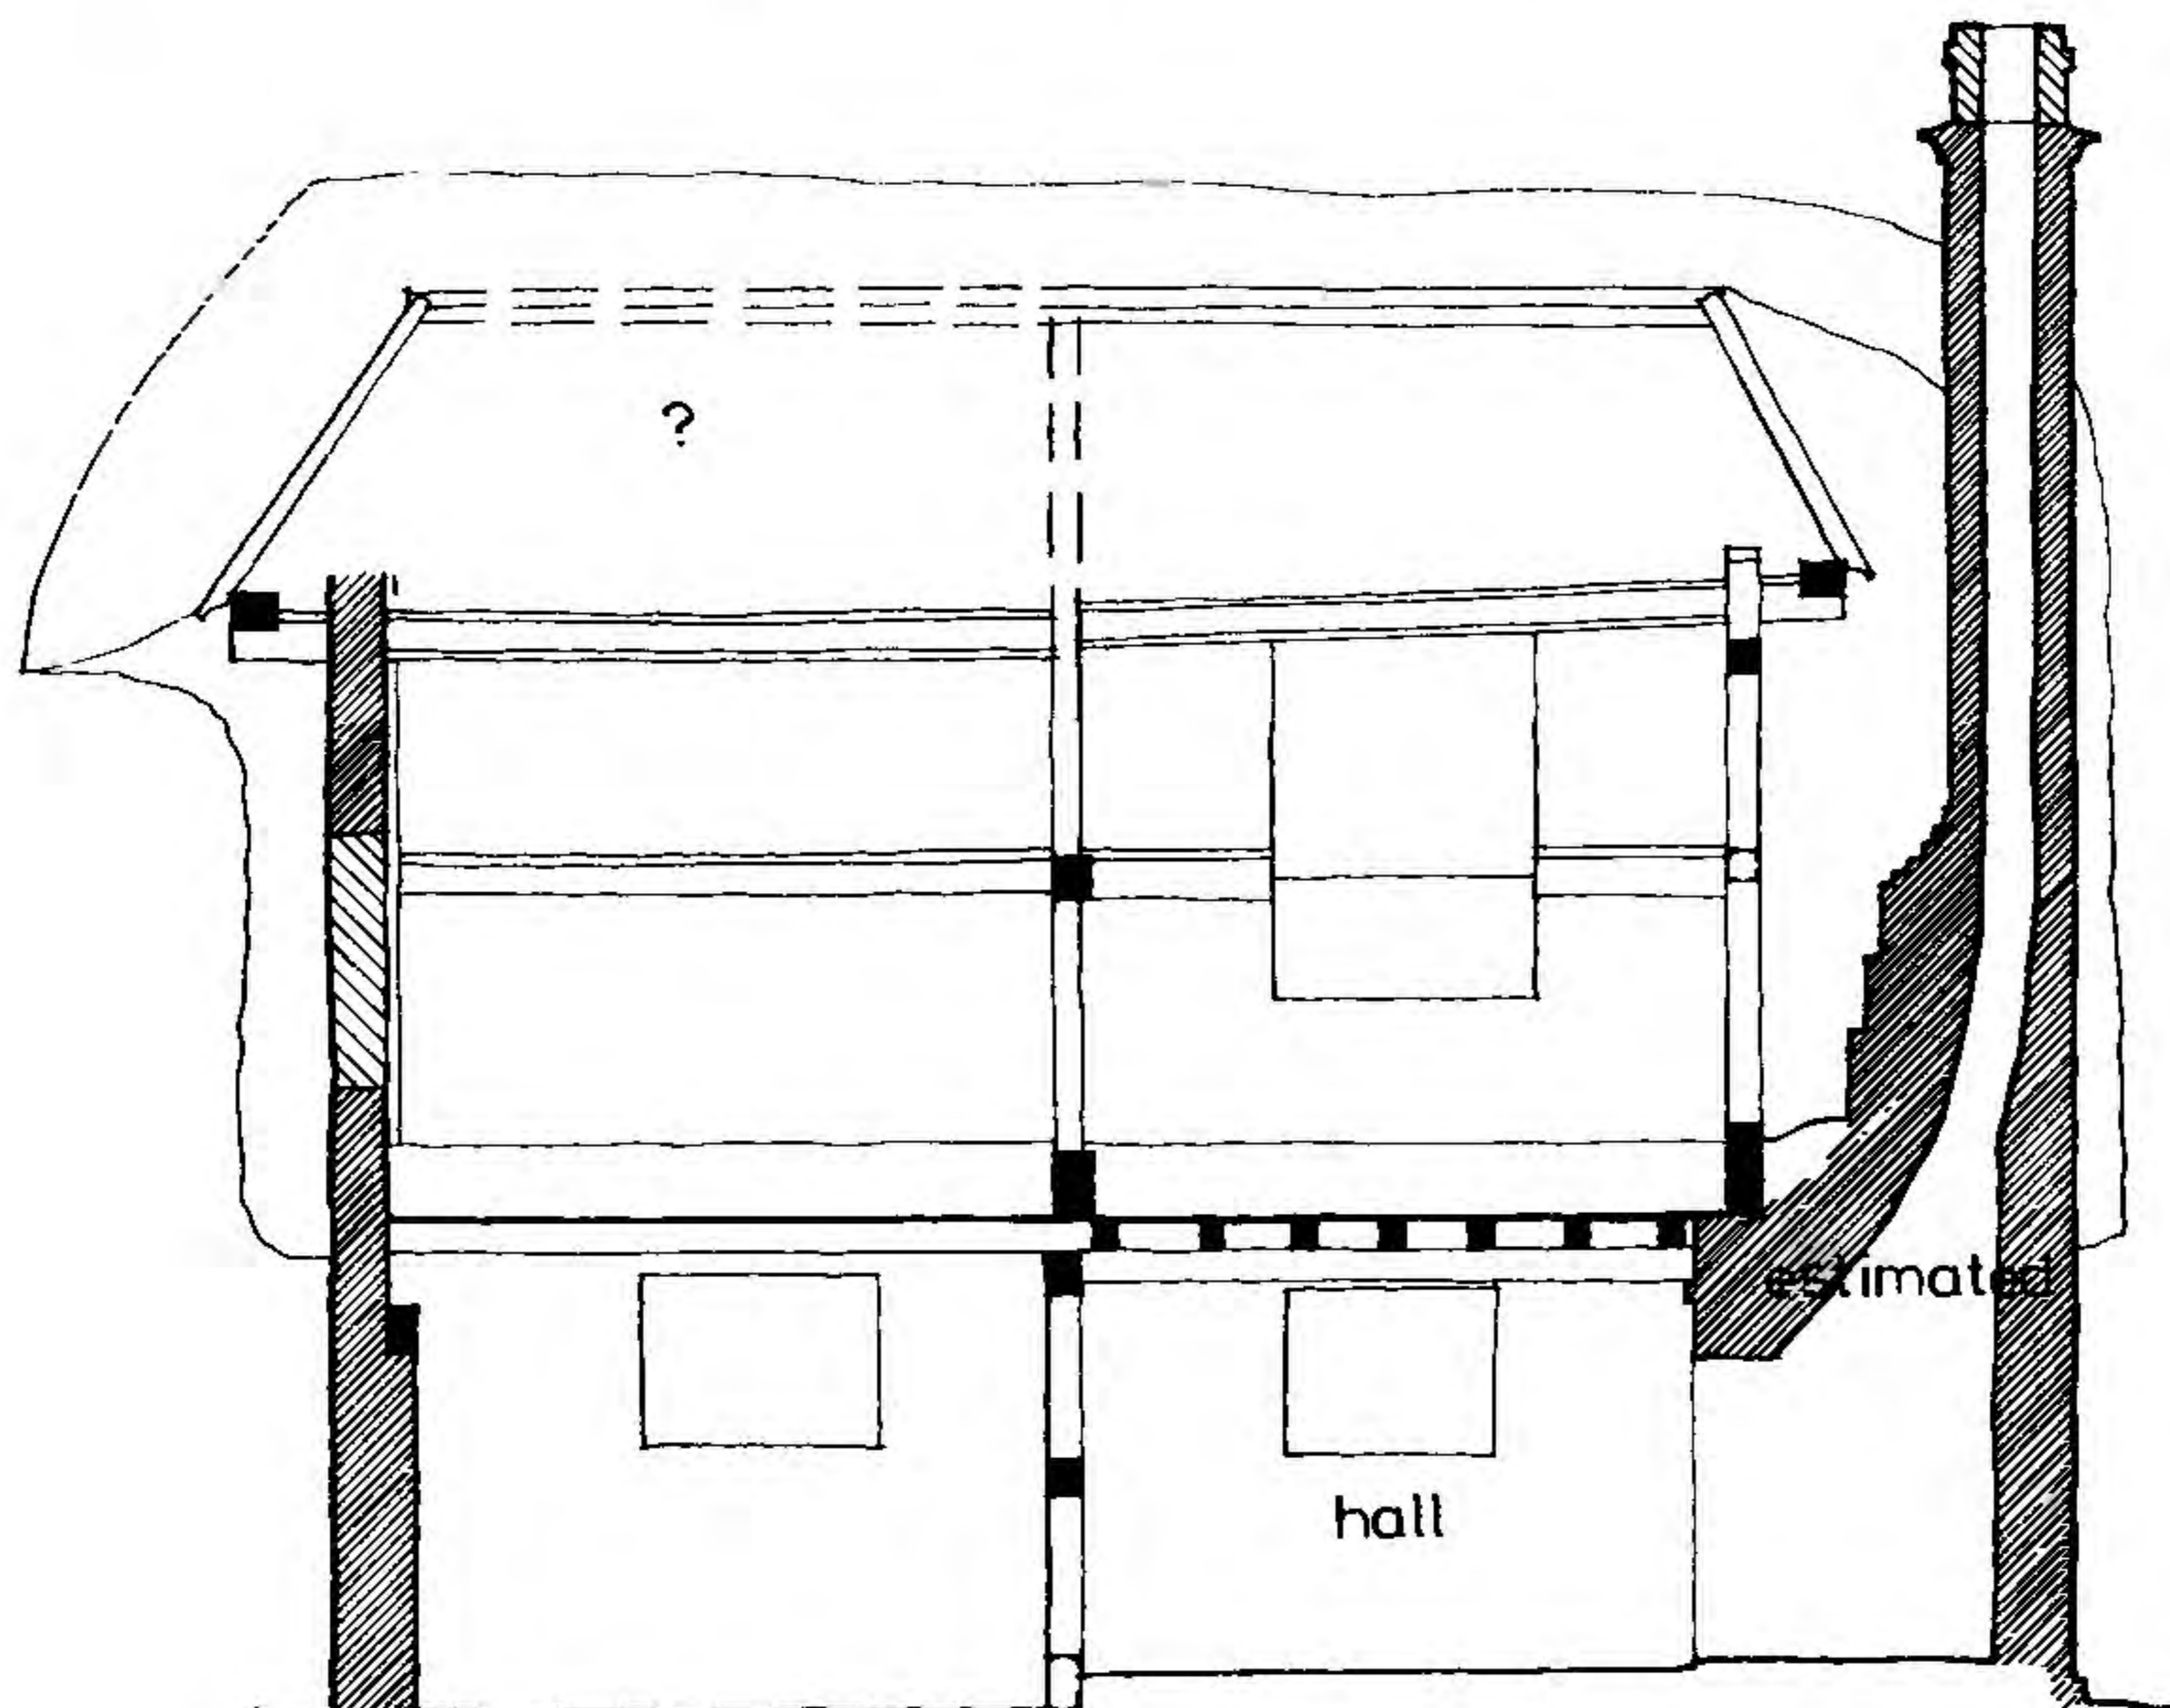
FIG. 2 The Old Bakehouse, Colethrop, Haresfield: section along the ridge. The entire roof space was originally open from end to end.

The three roof trusses were dissimilar. At the north-east gable the rafters were bird's-mouthed over the raised tops of the corner posts between which was a low-set tie beam. Elsewhere the posts carried the wall plate and tie beam in the usual manner. Apart from the collar beam, the central truss was intended to be open, though it was closed at a later date.

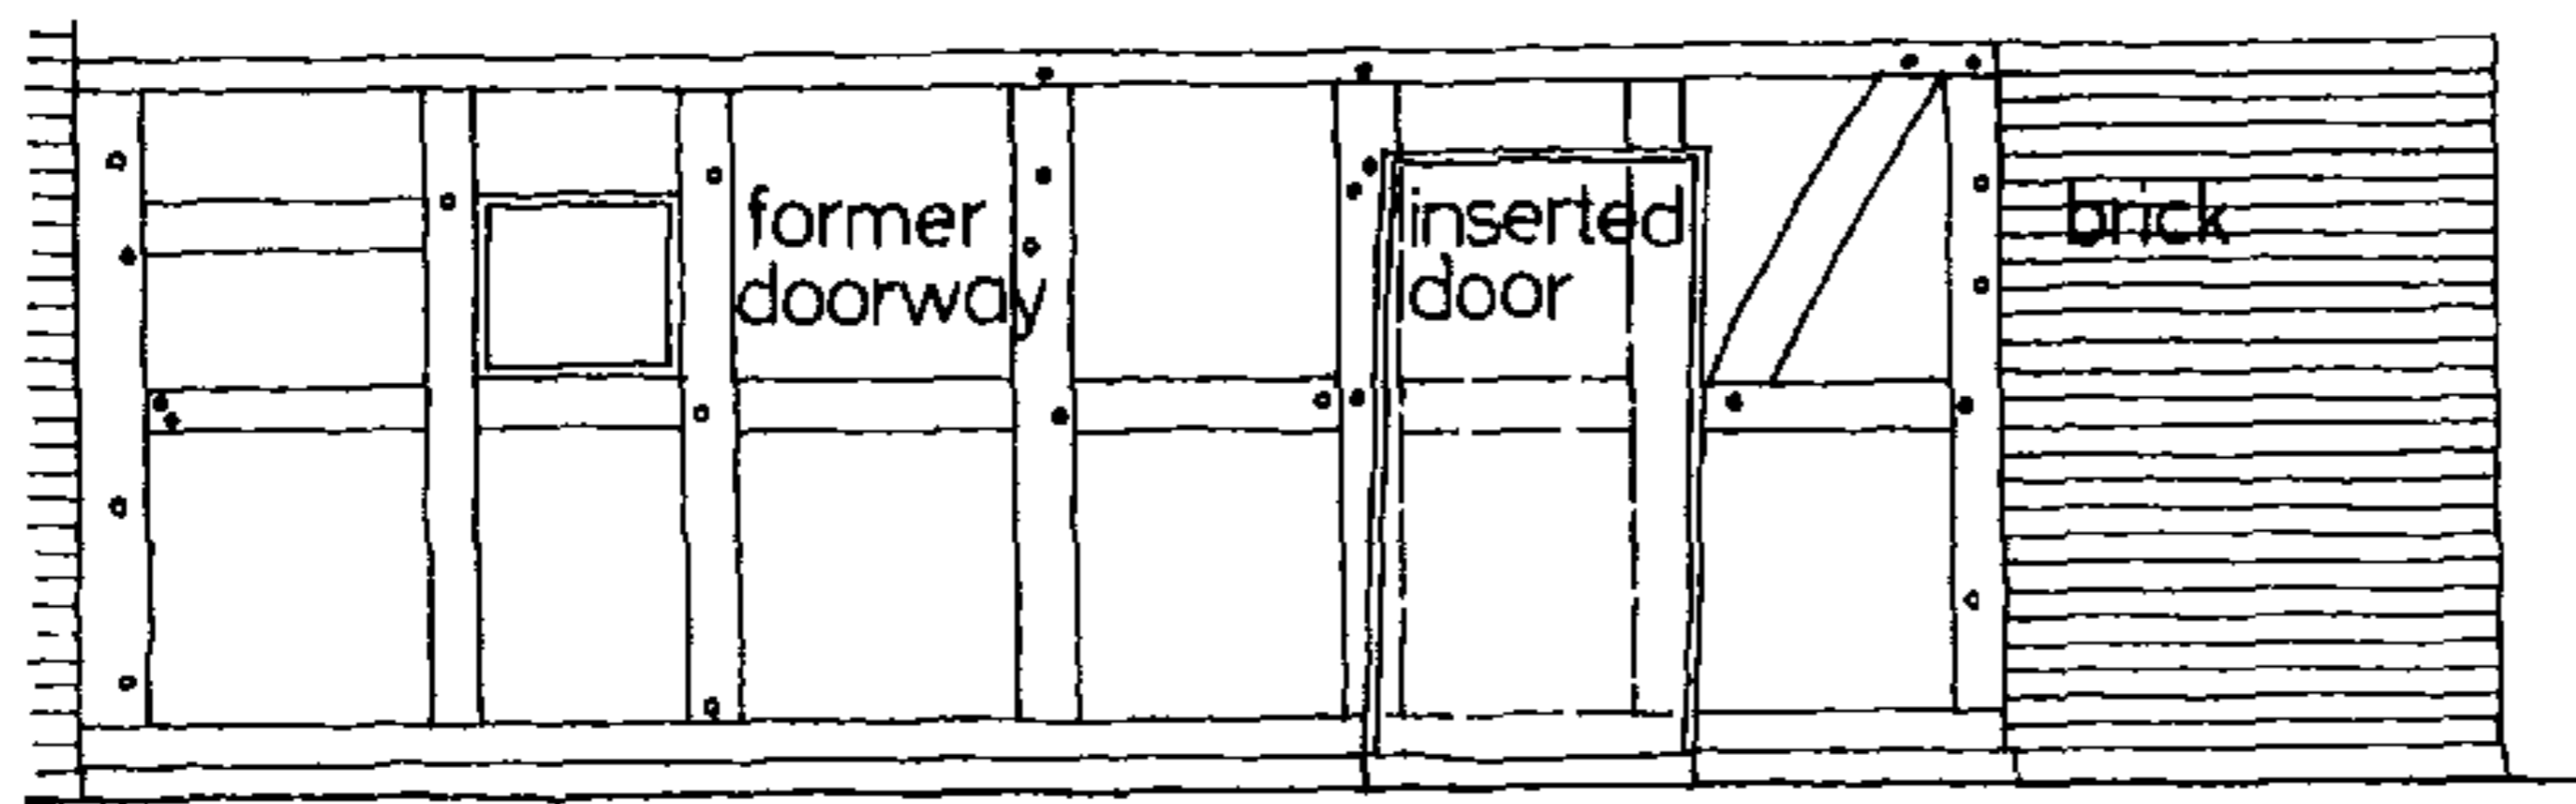
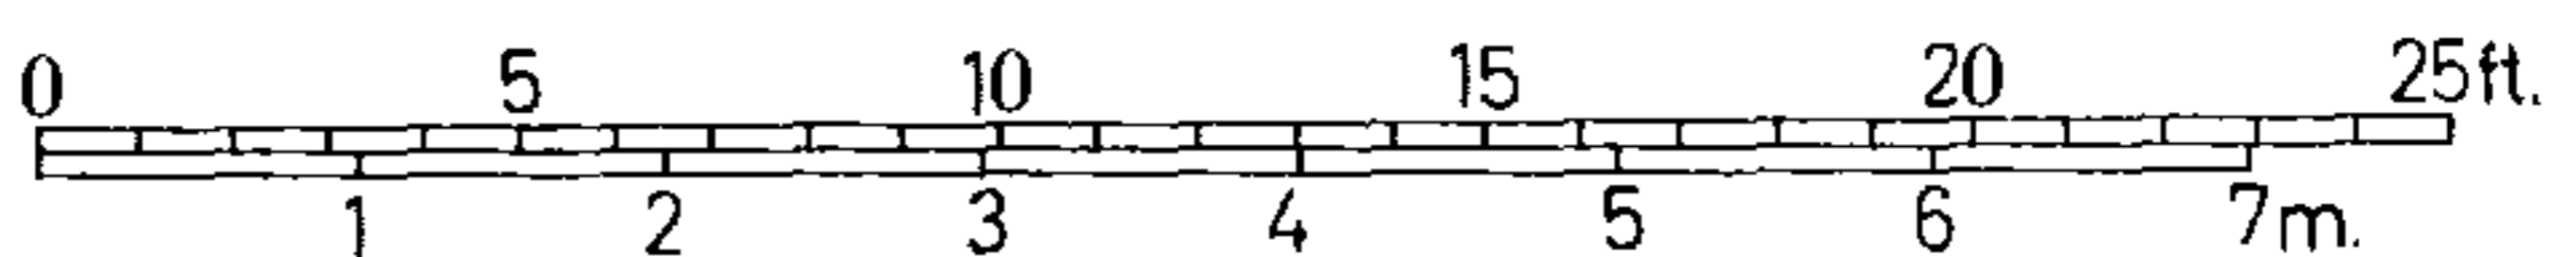
**THE OLD
BAKEHOUSE,
COLETHROP,
HARESFIELD**

FIG. 3 The Old Bakehouse, Colethrop, Haresfield: plan, elevation, and sections.

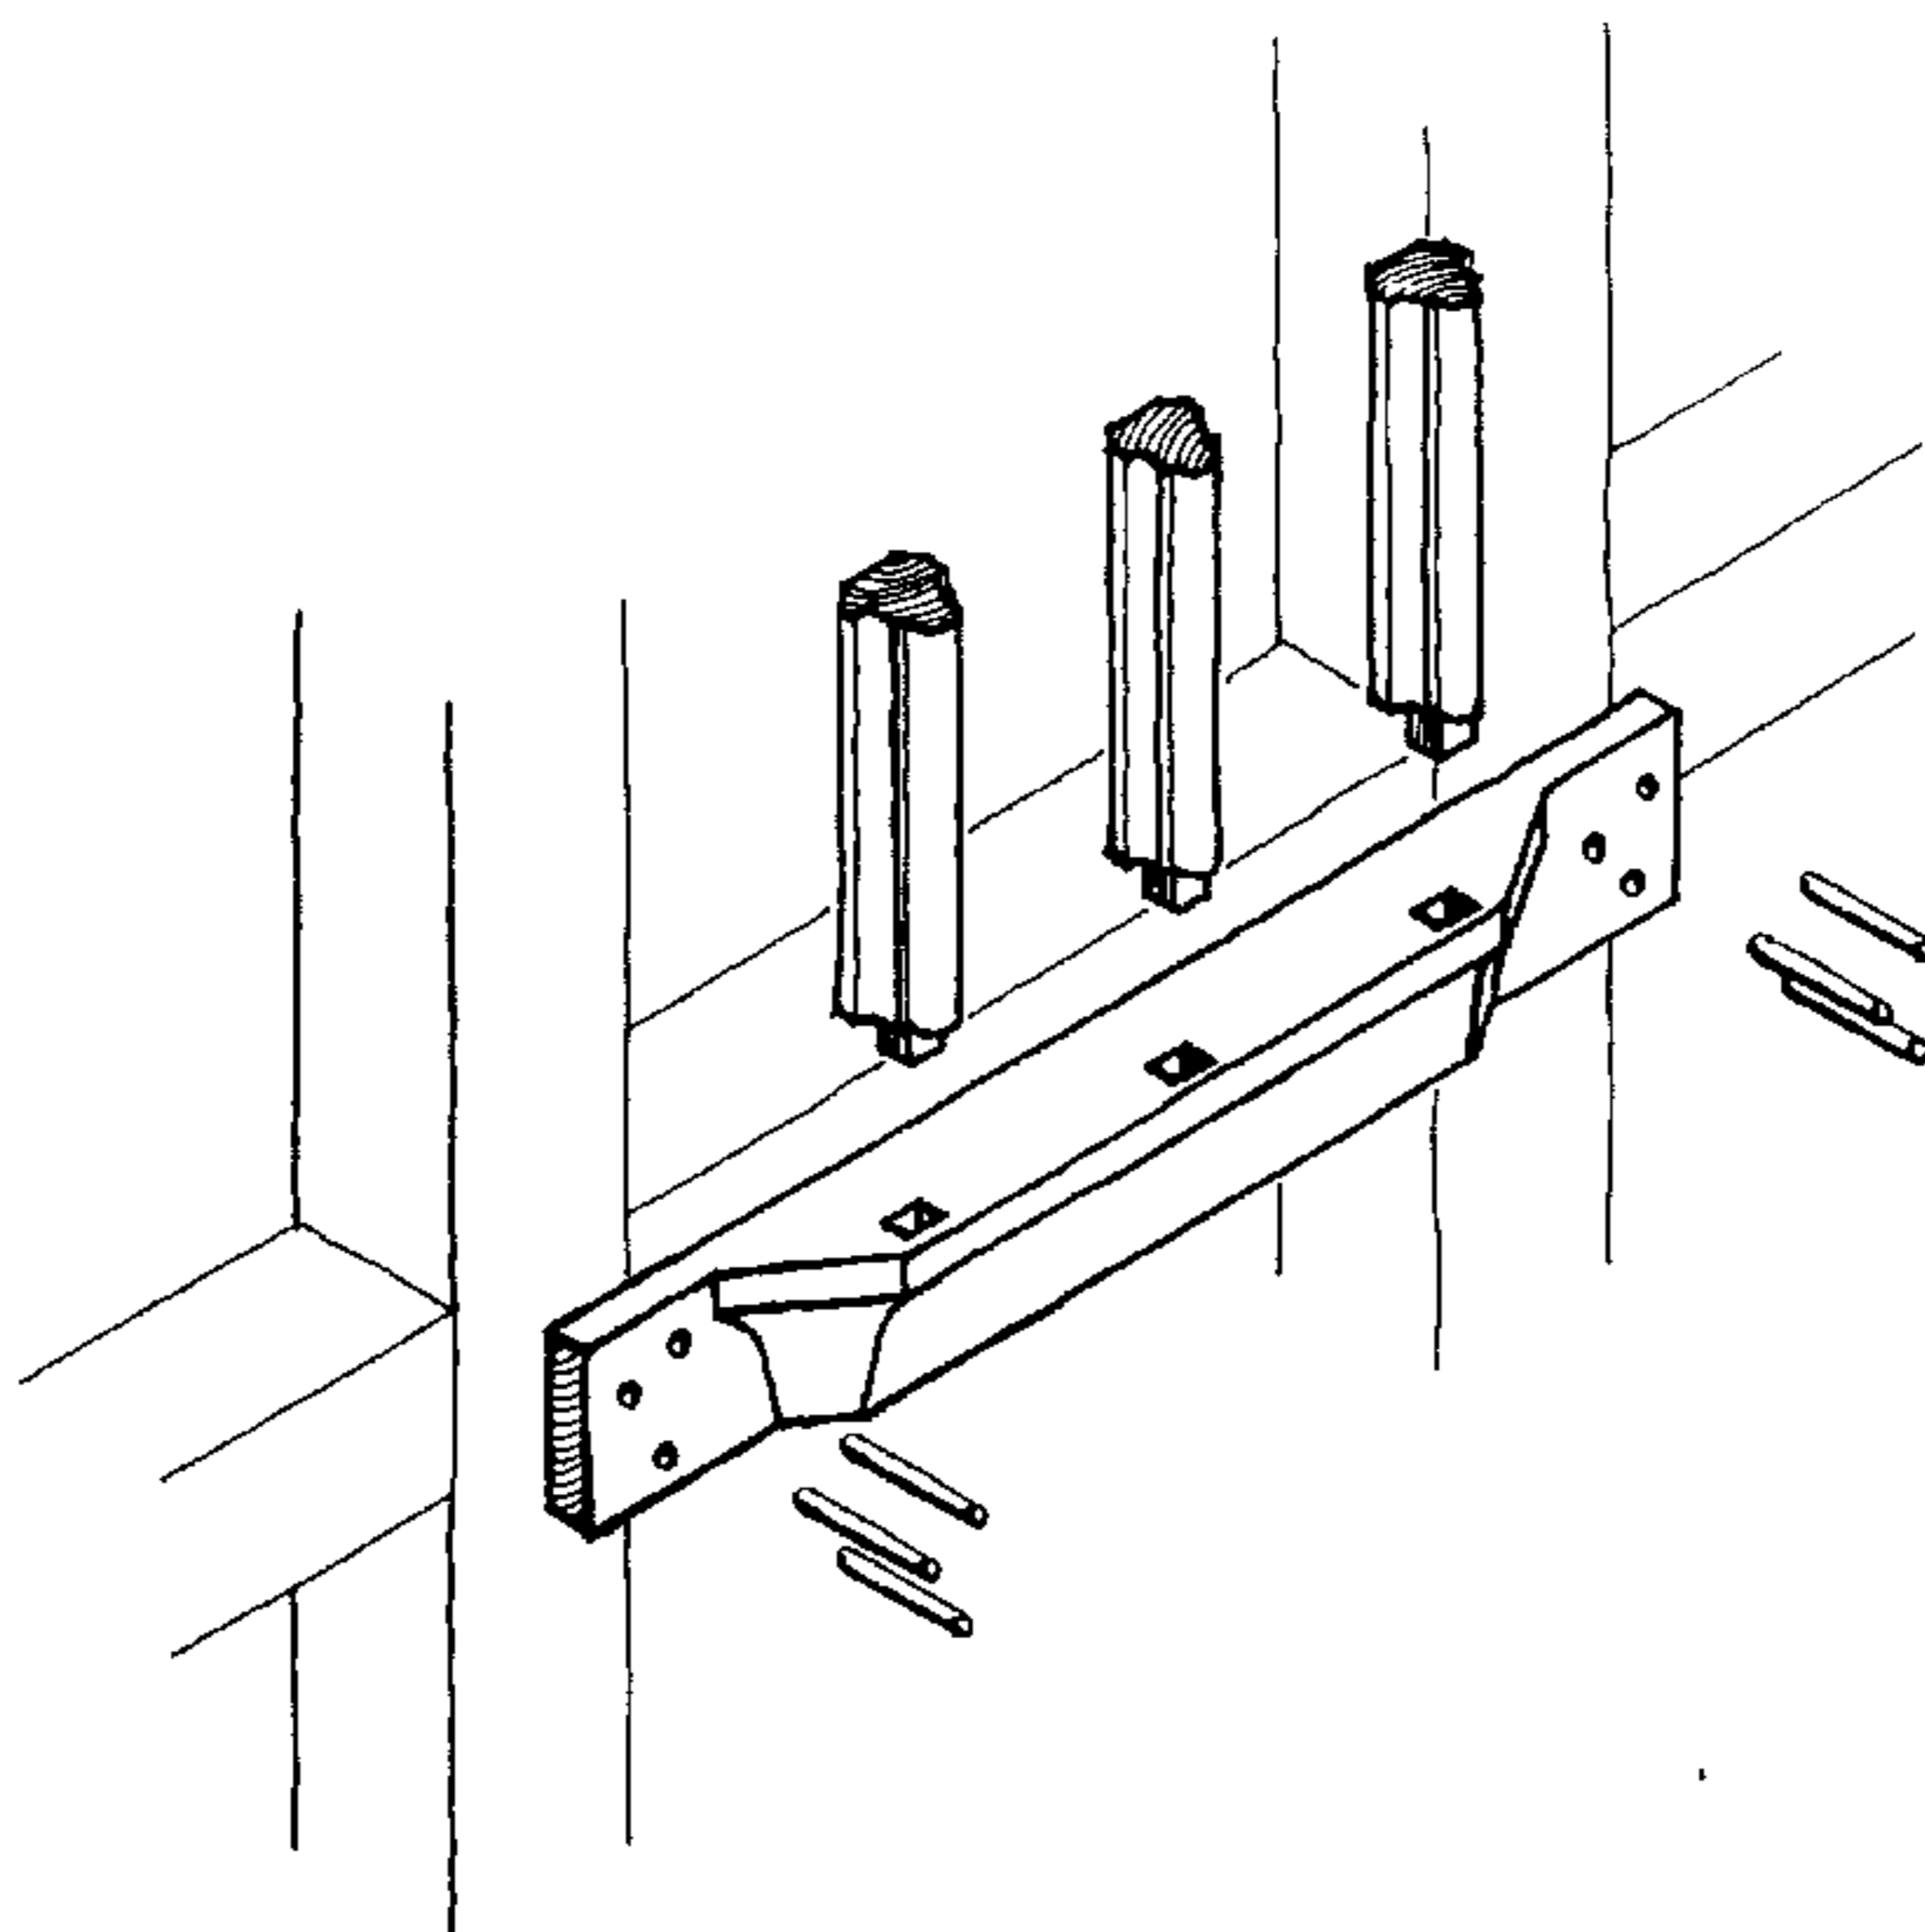
FIG. 4 Conjectural exploded view of the oriel window sill, not to scale.

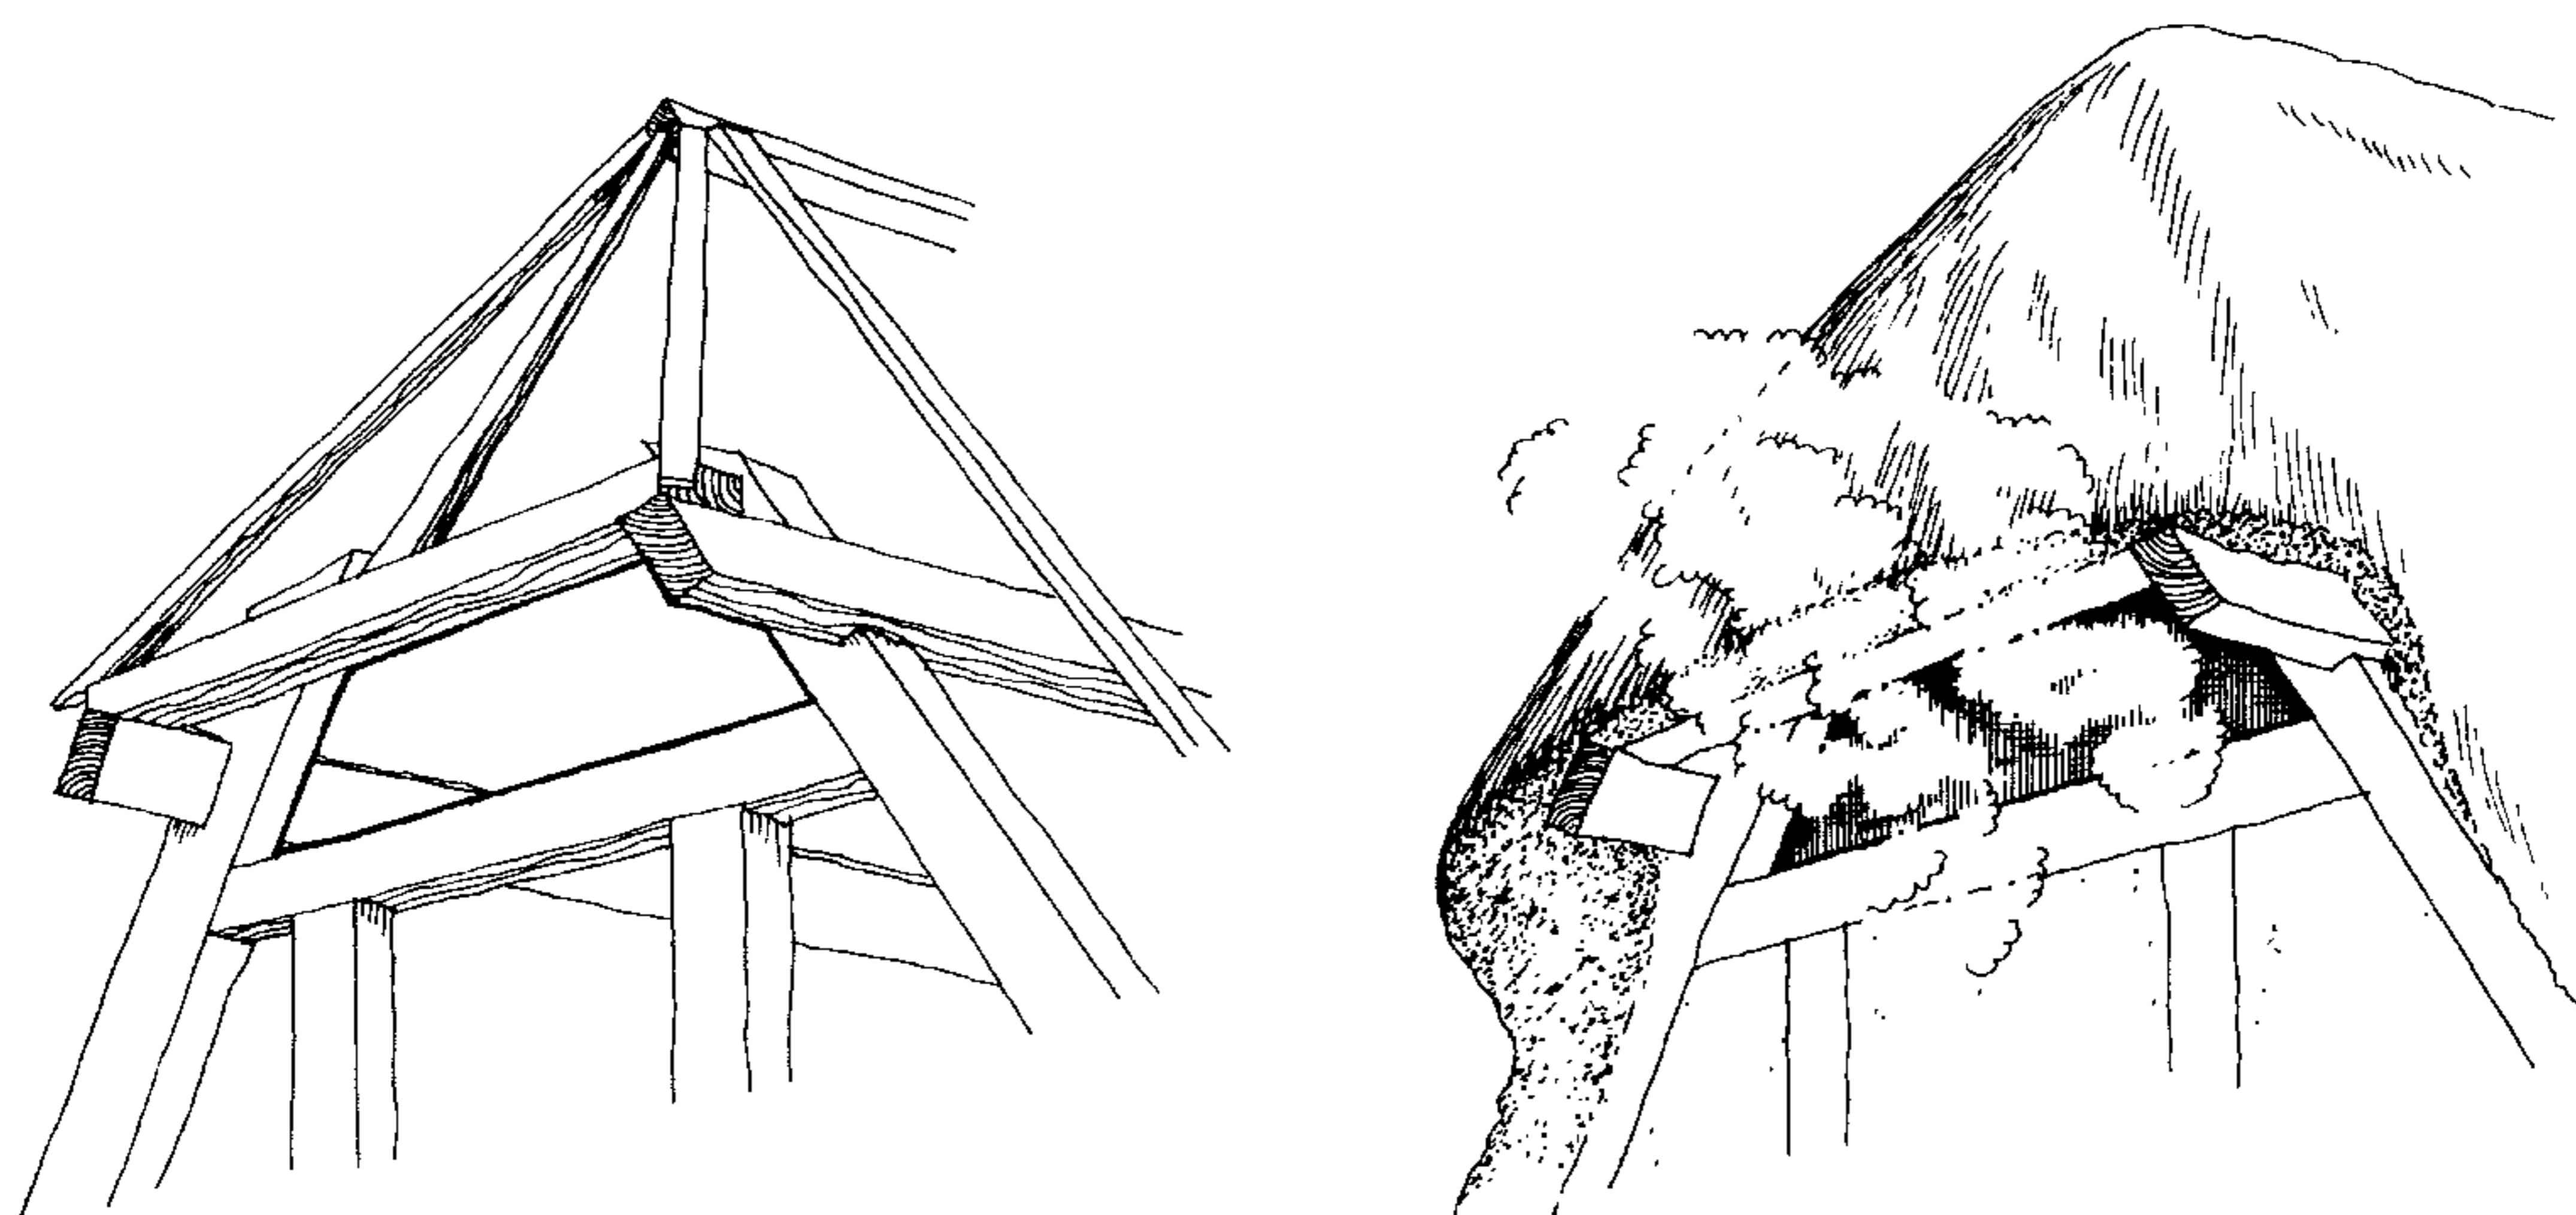
FIG. 5 Reconstruction showing the framework and function of a smoke vent, not to scale.

Smoke from the hearth in the hall would have filled the roof space, escaping at either end through vents under the half-hip of the thatch (FIG. 5). Both smoke vents had survived. One was examined in detail having been sealed in a void beside a chimney of *c.* 1600. The original thatch had gone, but the pattern of the smoke stains showed beyond all doubt, and for the first time in this county, that half-hip roofs could and did have a functional purpose.

The upper purlins were notched across the gable truss and extended to carry a hip plate. A small notch in the top of the plate carried a short rafter which joined others from either end of the plate at the ridge, which stopped short less than a foot inside the line of the truss. The truss itself was stopped short just above the collar. The smoke was sucked by external air turbulence over the collar and under the hip plate, which was completely blackened except for lines left by the ties which had held down the original thatch. At the opposite end such timbers as could be seen indicated a similar construction. The central hip rafter extended over the plate and a second plate had been inserted to support the thatch, which projected 4ft 6in (1.37m) beyond the footings.

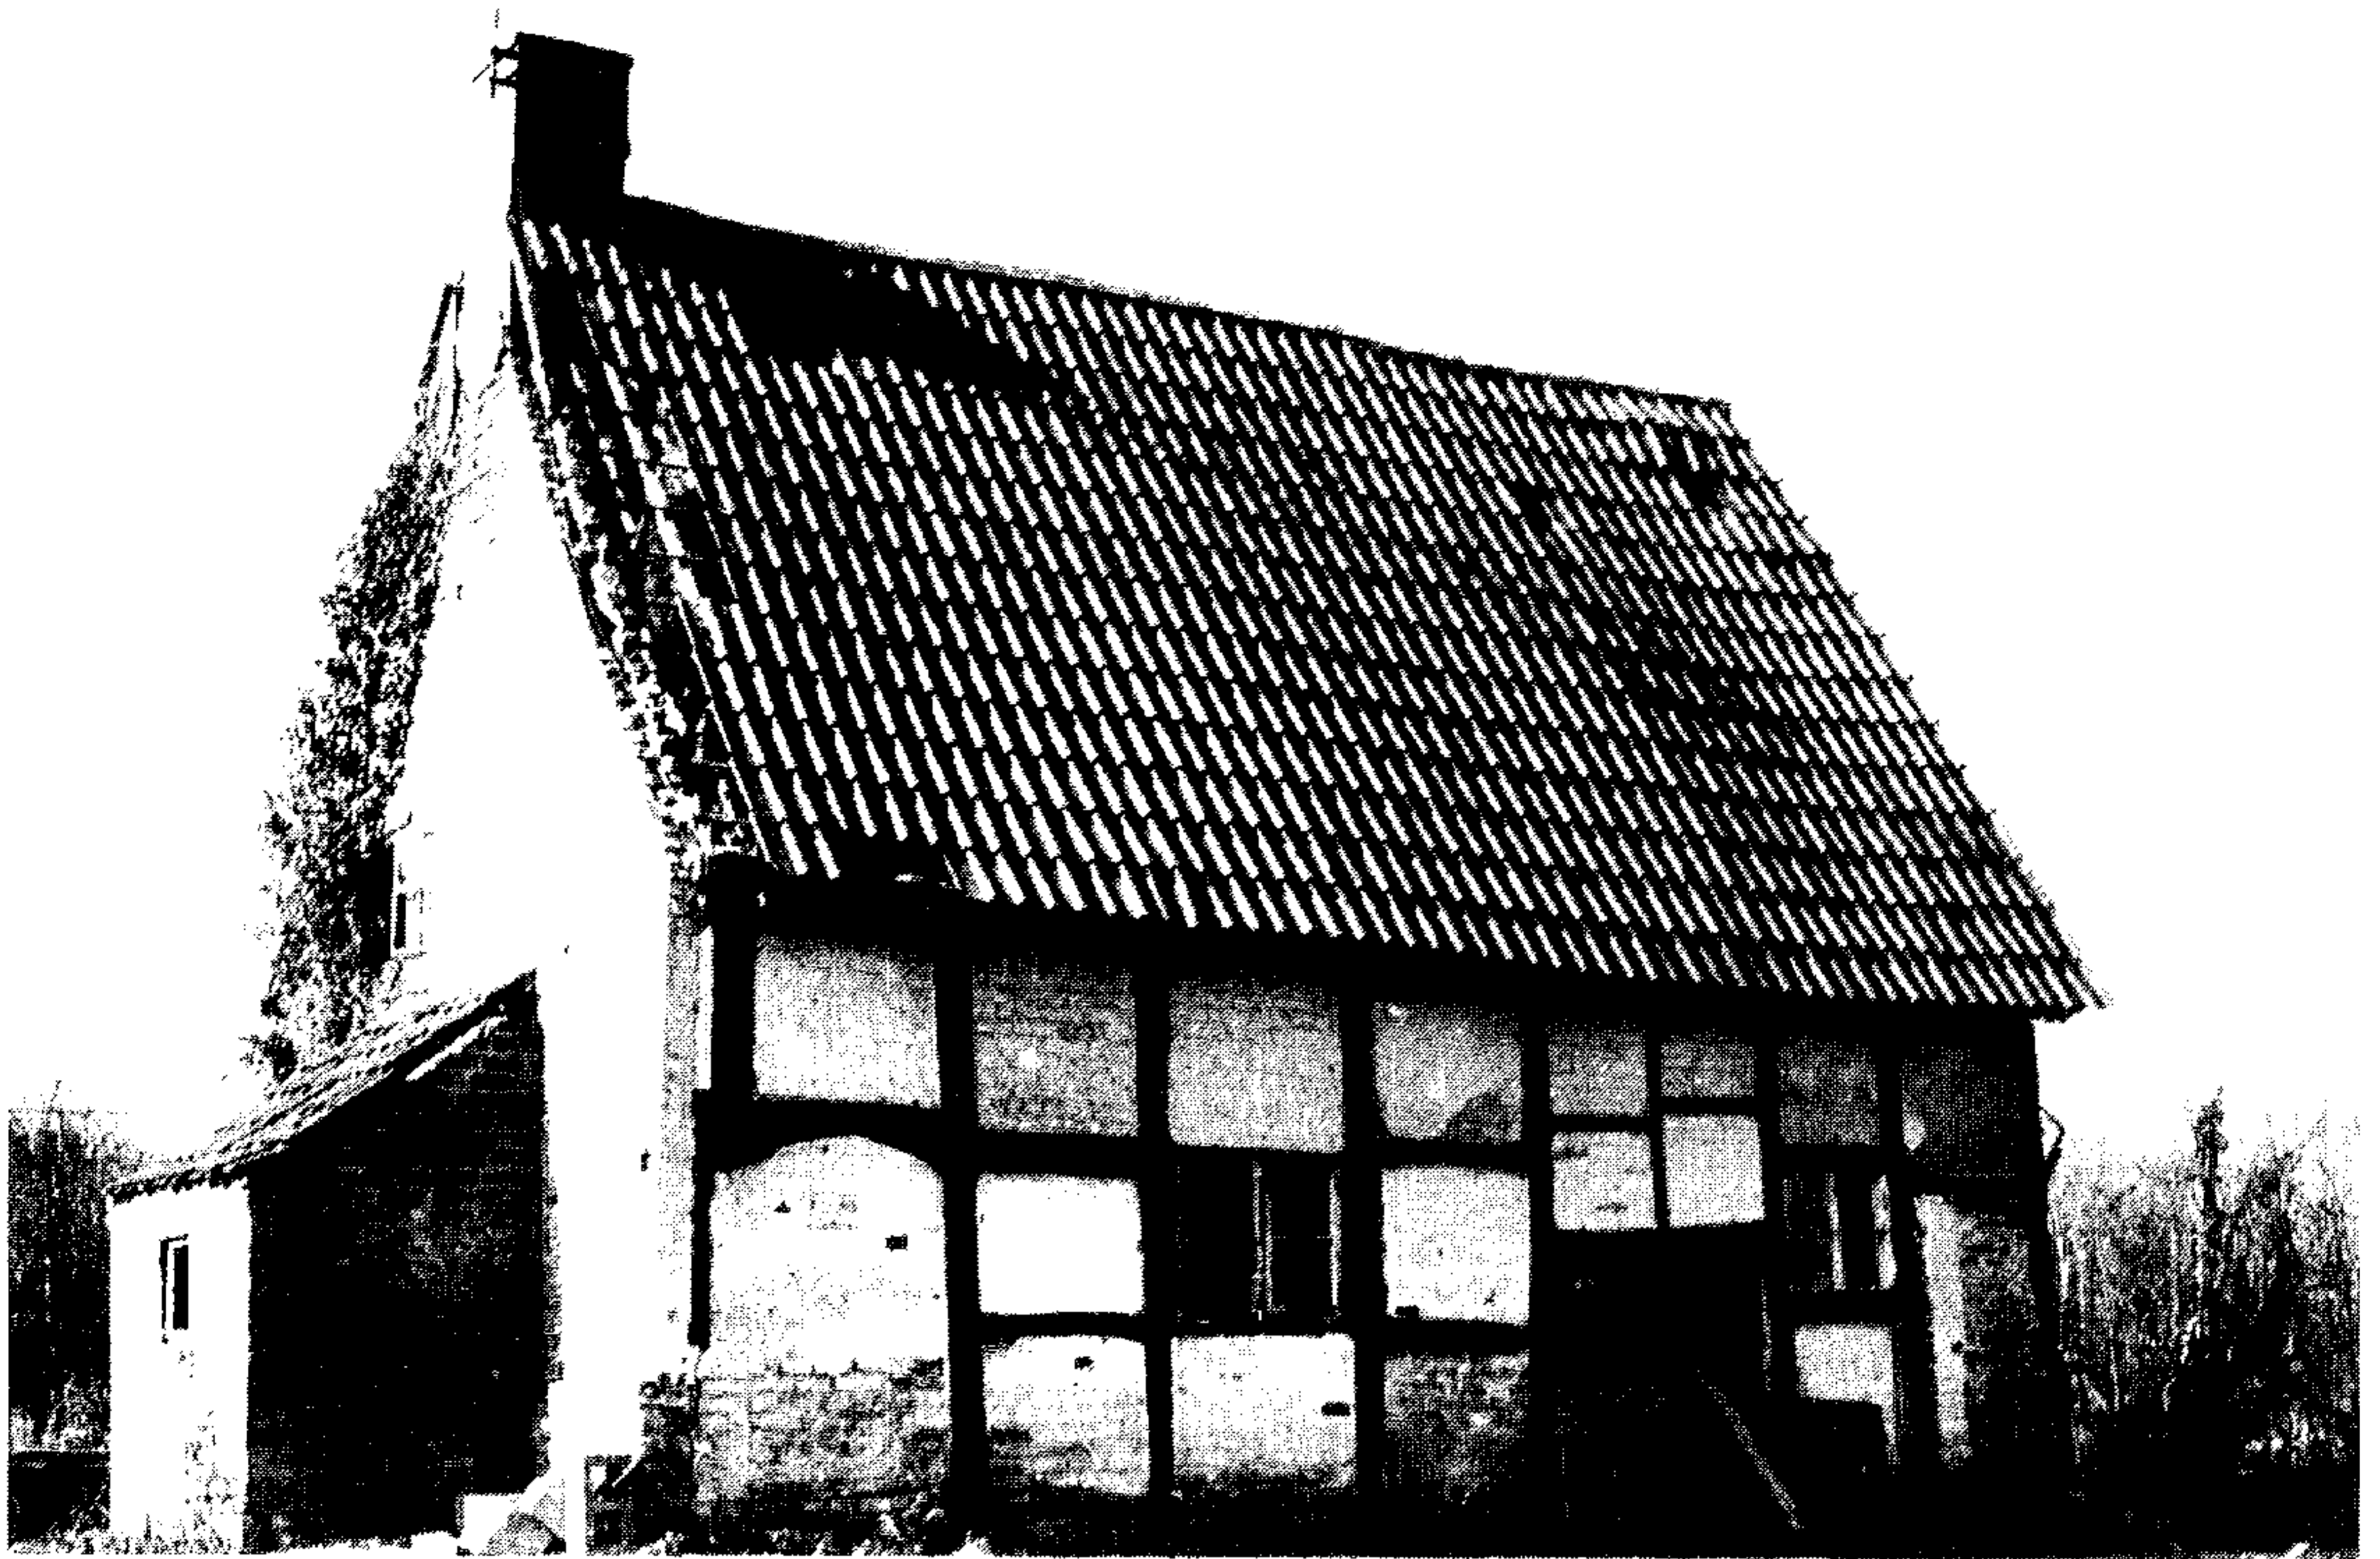
FIG. 6 Doris' Cottage, Epney, Moreton Valence: view from the south-east in 1985.

The panels comprising the east wall are of variable width. The shaped timber in the first is clearly a doorhead. The fifth has at some time suffered decay and contains later timbers, while the seventh originally contained a second doorway. Groups of three peg-holes suggest the former presence of two windows with oriel-type sills (see above and FIG. 4) across panels two, three, and six. The larger of these, lighting the hall, would appear to have had a bracket beneath the centre of the sill and ran from shoulder height, probably up to the line of the thatch. High-set windows were not uncommon in medieval houses (Walrond 1984, 312–313; Wood 1965, 59). The smaller window, lighting the inner room, was between the horizontal rails, and peg-holes survive for the lintel beam as well as the sill.
